# **Influence of Hold Time on Creep-Fatigue Behavior of an Advanced Austenitic Alloy**

September 2011

**Idaho National Laboratory  
Idaho Falls, Idaho 83415**

**Prepared for the  
U.S. Department of Energy  
Office of Nuclear Energy  
Under DOE Idaho Operations Office  
Contract DE-AC07-05ID14517**

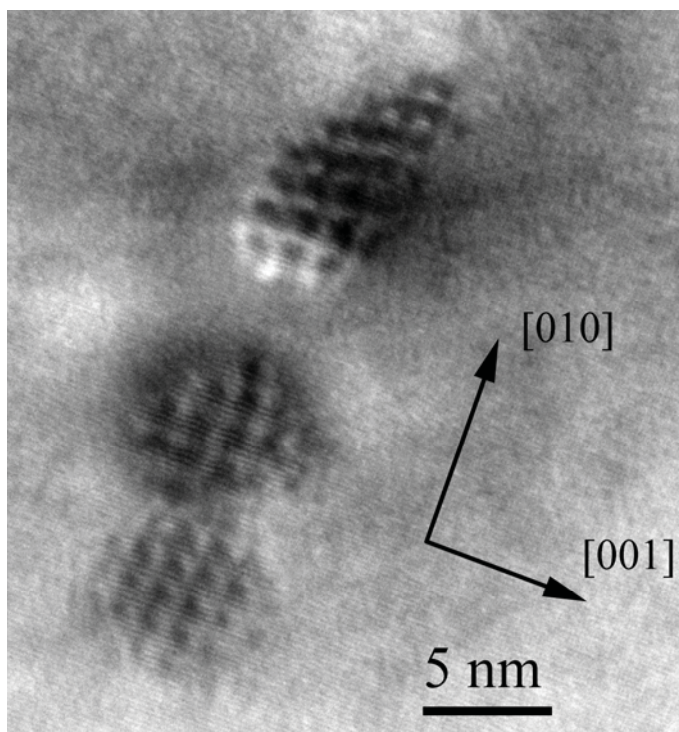
Figure 1. Nano-scale precipitates in the HT-UPS alloy demonstrate coherency with the matrix in the cubic orientation, as evidenced by the cuboidal Moiré fringe contrast. Image is taken slightly off of the [100] zone axis to enhance contrast.

The microstructure of the as-received HT-UPS plate is relatively homogenous, as shown by the optical image perpendicular to the rolling direction shown in Figure 2(a). Not considering the effect of the prevalent annealing twins on the shape and aspect ratio of a number of the imaged grains, the overall grain size is approximately 75  $\mu\text{m}$ . Cuboidal  $\text{Ti}(\text{C,N})$  precipitates approximately 1  $\mu\text{m}$  on edge are present throughout, as are the common  $\text{Cr}_{23}\text{C}_6$  precipitates decorating grain boundaries. TEM imaging revealed the notable absence of any of the ultra-fine MC precipitates, and showed various arrays of mobile dislocations within the austenitic grains, as shown in Figures 2(b) and 2(c). In the as-received state, no nanoscale MC carbides were observed to have precipitated at these dislocations.

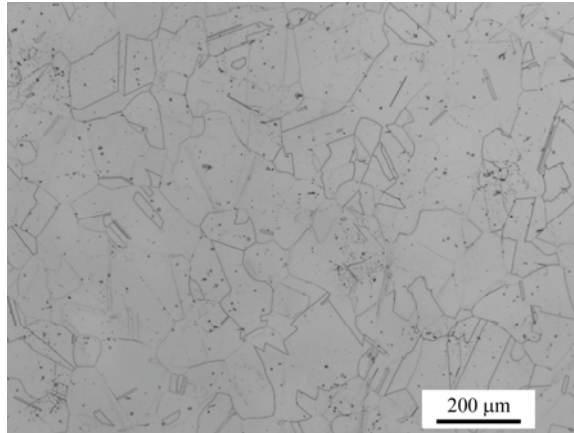
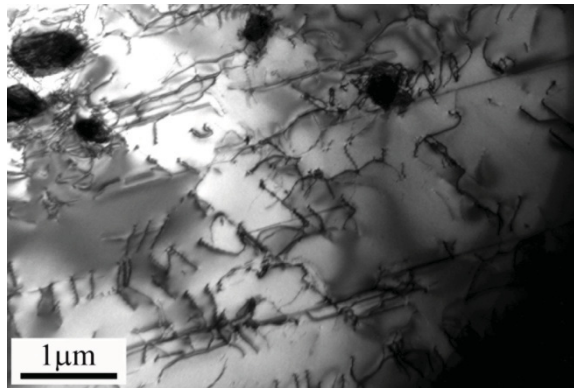
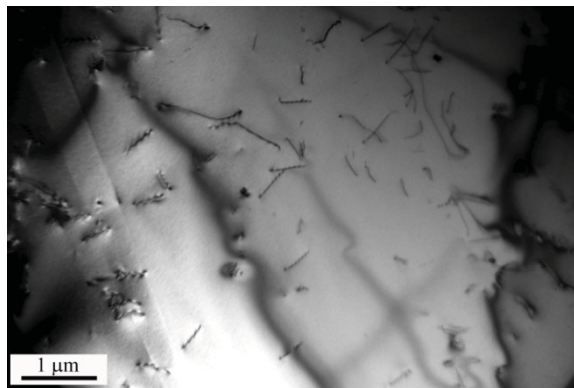
Figure 2. Optical image (a) and transmission electron microscope image (b, c) of the as-received microstructure of the HT-UPS alloy.

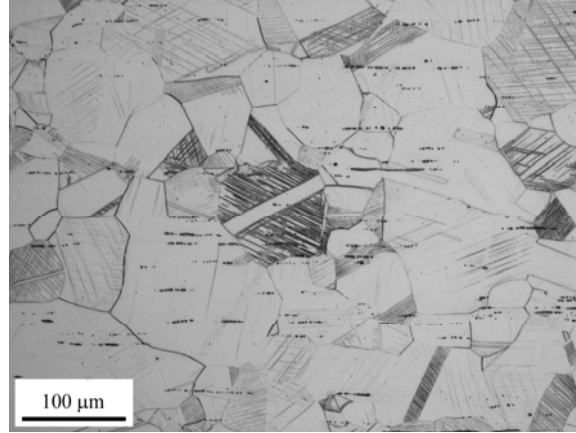
Figure 3. Slip bands resulting from forming operations are readily visible in the grains of rolled 316 SS.

The grain size of 316 SS in the cold drawn condition (CD) is slightly smaller than that of the HT-UPS hot-rolled plate. Evident in many of the grains of the CD material are slip lines attributable to deformation during the cold drawing operation, as shown in Figure 3. The hot rolled (HR) 316 SS plate grain size, by contrast, is considerably smaller at approximately 25  $\mu\text{m}$ . Another observable feature is the volume fraction of sulfide stringers that can be observed running parallel to the rolling direction.

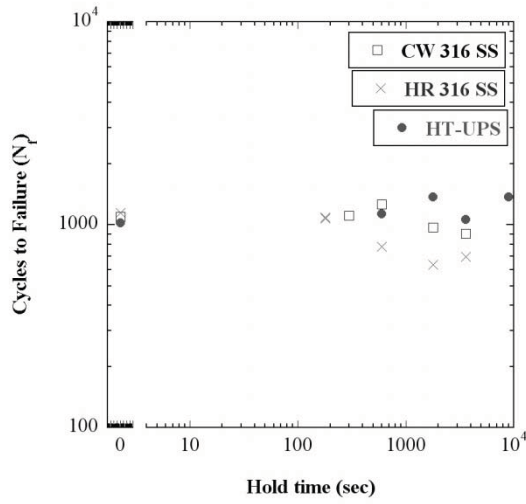
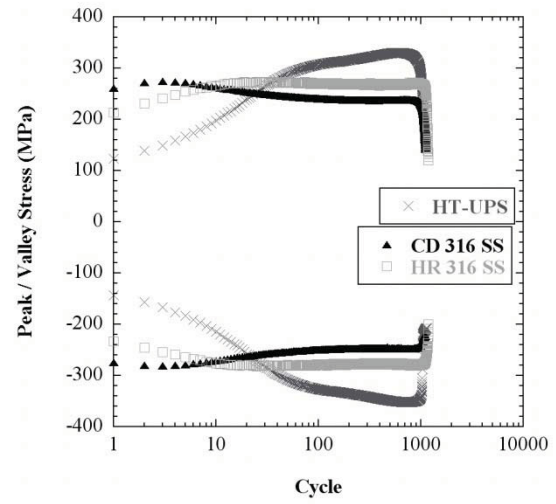
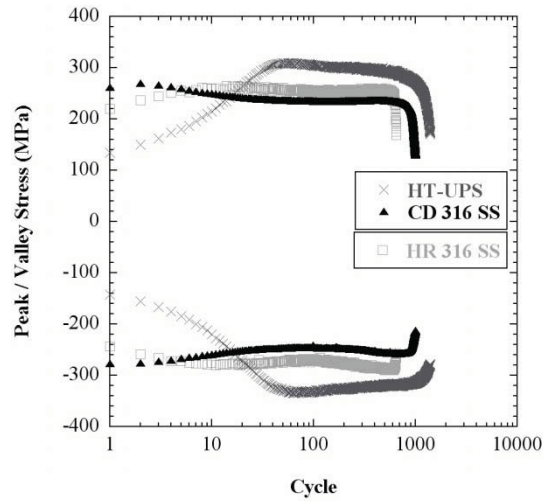
Figure 4. Fatigue and creep-fatigue at 650°C and a total strain range of 1.0% of HT-UPS, cold drawn (CD) 316 SS, and hot rolled (HR) 316 SS. Cycles to failure as a function of hold time (a), peak tensile stresses as a function of cycle for continuous cycling (b), peak tensile and compressive stresses for creep-fatigue with a  $1.8 \times 10^3$  sec hold (c).

Extensive low-cycle fatigue and creep-fatigue testing of the 316 SS and HT-UPS was conducted on servo-hydraulic load frames. The quantified cycles-to-failure values in both fatigue and creep-fatigue of the HT-UPS and the 316 SS (both CD and HR) are similar, although the respective trends in deformation response during cycling is quite different. A summary of the fatigue and creep-fatigue results are given in Table II. Figure 4(a) is a plot of the cycles to failure as a function of hold time for the 316 SS and HT-UPS at 650 °C. Evident from this plot is the observation that increased hold times of up to  $3.6 \times 10^3$  sec did not degrade the creep-fatigue life of either alloy relative to continuous-cycle fatigue. Furthermore, a test with a  $9.0 \times 10^3$  sec hold time conducted on HT-UPS demonstrated that the lifetime with regard to cycles to failure is similar or better to that of the shorter hold time tests.

Despite the absence of a measurable difference in the cycles-to-failure values, the hardening behavior of the two alloys demonstrates considerable variation. The maximum and minimum stresses during both the continuous cycle and creep-fatigue tests with a  $1.8 \times 10^3$  sec hold are shown as a function of cycle in Figures 4(b) and 4(c), respectively. At the onset of continuous cycling, the HT-UPS alloy exhibits relatively low tensile and compressive peak stresses which quickly build up resulting from significant cyclic hardening. These stresses more than doubled during the first 60 cycles, increasing from 120 MPa to 320 MPa, then continued to build slowly with increasing cycle counts until macrocrack initiation was noted. No steady state value is achieved at any point during the deformation process. The HR and CD 316 SS, by contrast, have considerably higher initial levels of peak stress of approximately 275 MPa, but further cycling beyond this peak value resulted in softening behavior. When a hold time is introduced, the creep-fatigue deformation exhibits similar behavior - except that HT-UPS demonstrates cyclic softening behavior beyond the peak value similar to that seen in 316 SS. Hysteresis loops for both CD 316 SS and HT-UPS are also an important indicator of differences in deformation behavior (shown in Figure 5 at cycles 1, 10, 100, as well as for the midlife cycle) for both a fatigue test and a creep-fatigue test with a  $1.8 \times 10^3$  sec hold. The overall inelastic strain (the measured strain spread at zero stress) does not change significantly with increasing cycles in the CD 316 SS, while the cyclic hardening observed in the HT-UPS steel is highly evident from the decreasing width of the hysteresis loops.

The rapid cyclic hardening exhibited for HT-UPS in Figures 4 and 5 suggests that extensive precipitation of the ultrafine MC phase occurs during the first 100 strain cycles, whether in fatigue or creep-fatigue. Fine MC precipitates have not yet formed in the as-received material despite the presence of a discernable dislocation density remaining from the hot rolling operation. This observation is consistent with previous work on AX-5, an HT-UPS alloy of similar composition [6]. After a solution-annealing treatment at 1250°C, Todd and Ren reported the exclusive presence of larger precipitates, which were classified as likely remnants of carbonitrides, and no dispersion of fine MC precipitates [6]. Aging of the AX-5 for 10 hours at 700°C resulted in an extensive amount of fine MC precipitates, whereas aging at the reduced temperature of 600°C revealed the presence of relatively few MC precipitates even after 300 hours [6]. Despite the absence in the as-received state, the nano-scale MC phase likely precipitated relatively quickly at the 650°C test temperatures when the application of cyclic strains introduced the necessary density of matrix dislocations. Further work will endeavor to extract the nucleation condition driving precipitate formation with regard to dislocation-dislocation interactions. While coplanar dislocation arrays resulting from uniaxial rolling operations may not provide the requisite driving force for MC coalescence and precipitation, the rapid buildup of dislocation tangles with larger strain fields resulting from proximate jogs and kinks might provide the necessary impetus for formation and growth.

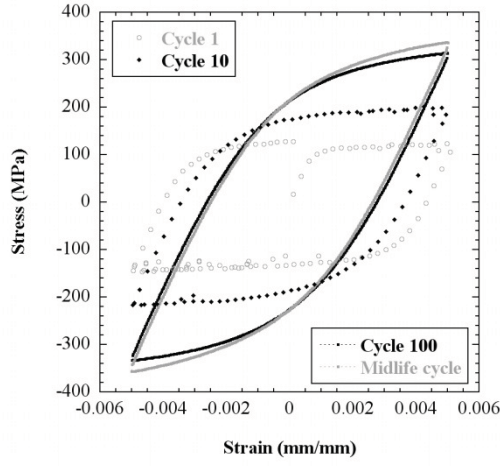
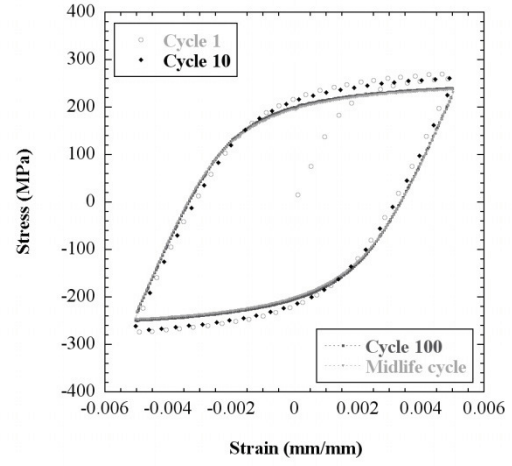
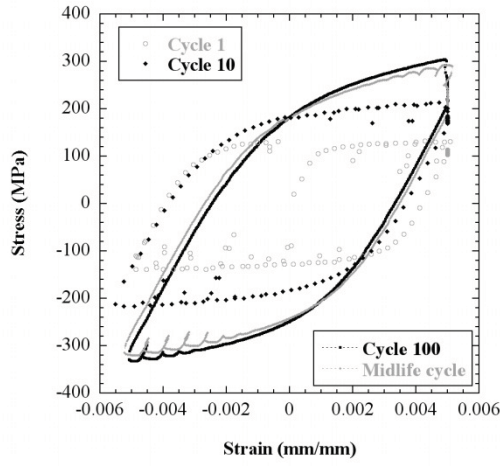
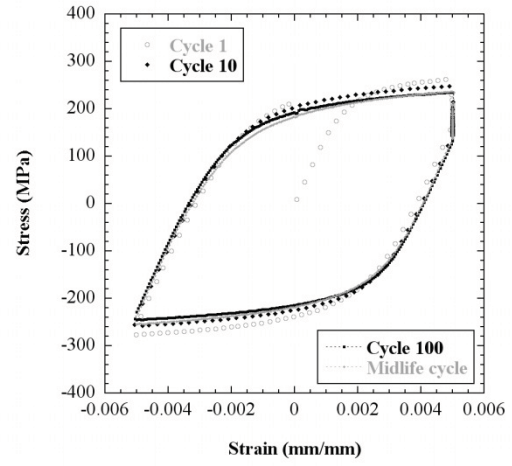
Figure 5. Hysteresis loops from low cycle fatigue deformation of HT-UPS (a) and 316 stainless steel (b) at 650°C and a 1% total strain. Hysteresis loops from creep-fatigue deformation of HT-UPS (c) and 316 stainless steel (d) at 650°C, 1% total strain, and a  $1.8 \times 10^3$  sec hold time.

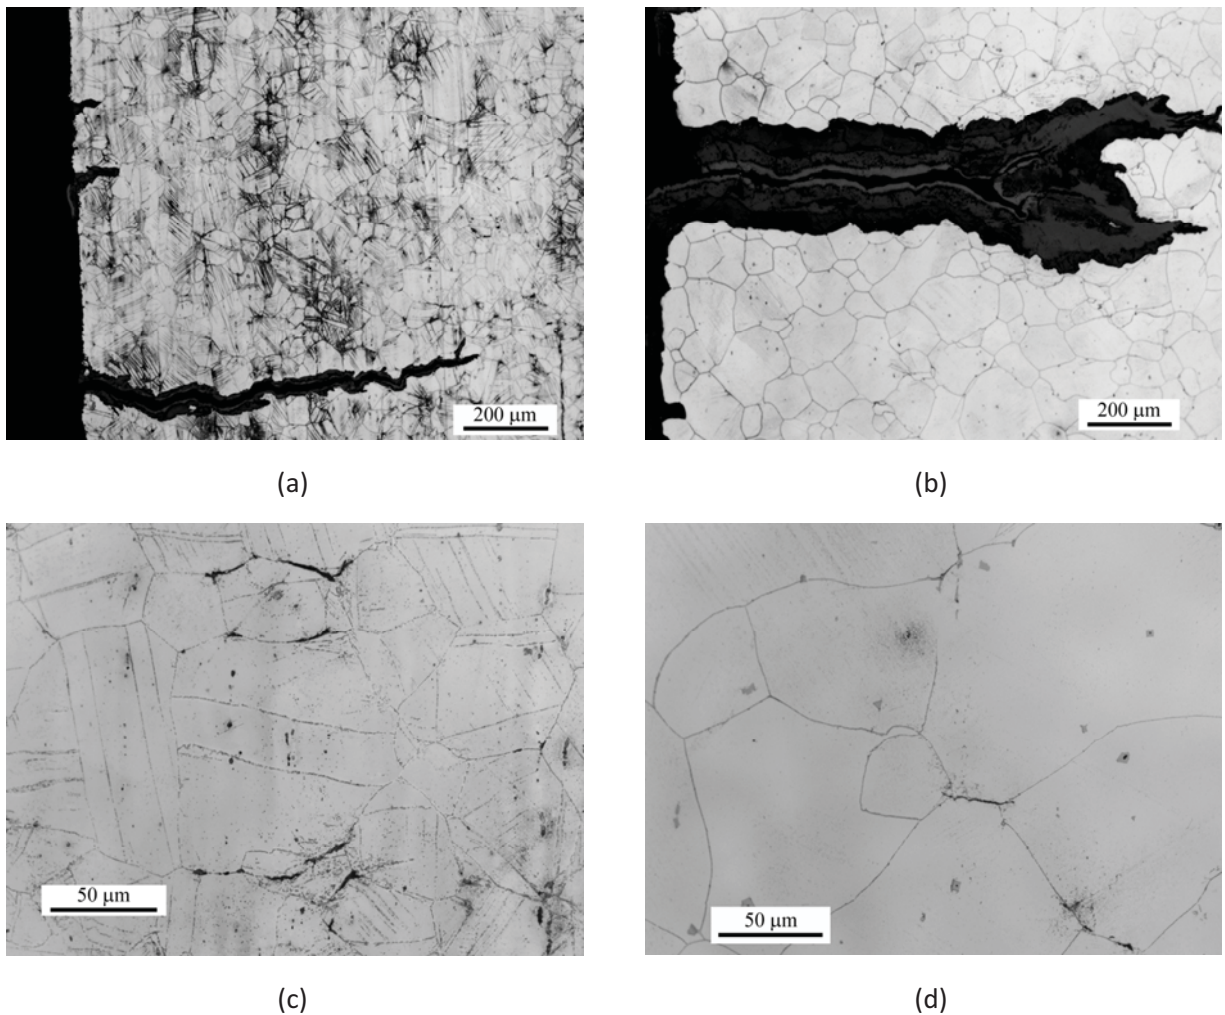
Figure 7. Images of the macroscopic surface and interior cracking in creep-fatigue specimens tested at a 1% total strain range, 650°C, and a  $3.6 \times 10^3$  sec hold of CD 316 SS (a, c) and HT-UPS (b, d).

Continuous cycling resulted in cracks initiating in a transgranular manner at the specimen surface, while creep-fatigue cycling resulted in intergranular surface crack initiation. In both the continuous-cycle and peak hold time specimens, propagation beyond the crack initiation is transgranular, as is shown in Figure 7(a) for a  $3.6 \times 10^3$  sec creep-fatigue specimen. Shorter “secondary” cracks are also observed, and extend several grain diameters below the specimen surface. Branching of the cracks is clearly seen in all cases, particularly at grain boundary intersections. Despite this branching at oxidized grain boundaries, the cracks that continued to propagate were transgranular. The surface regions of both the primary and secondary cracks also exhibited an established oxide layer. Careful compositional analysis reveals that the oxide consists of two types; nearest the base metal, the oxide is rich in Fe, Cr, and Ni, while sandwiched between the outer layers of Fe-Cr-Ni oxide is a Fe-rich oxide with relatively little Cr or Ni. A small

The fatigued HT-UPS specimens exhibit widespread and very fine cracks along the specimen surface, initiating and propagating in a transgranular manner. No oxide is visible in optical microscope length scales. With the addition of a 600 sec hold time, the resulting oxide layer on the crack surfaces is visibly thicker, as is shown in Figure 7(b), and the surface cracks initiated intergranularly. Similar to the CD 316 SS, crack propagation is transgranular and a two-layer oxide is present (a Fe-rich oxide sandwiched between a Fe-Cr rich oxide). However, the intergranular surface oxidation and surface oxide, particular in the longer hold time tests, is much more extensive in HT-UPS than 316 SS. An image of intergranular surface oxidation at the specimen surface in a creep-fatigue specimen of HT-UPS with a  $3.6 \times 10^3$  sec hold time is shown in Figure 8.

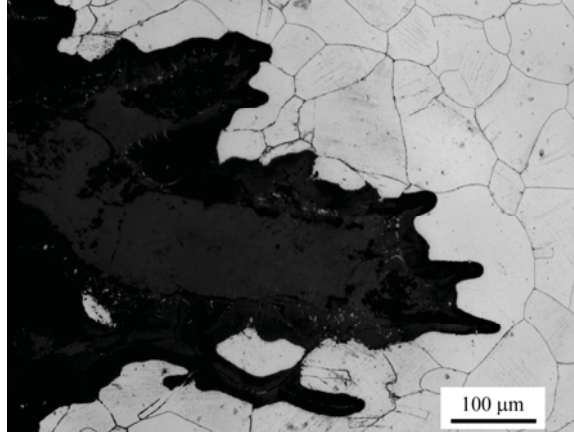
Figure 8. The oxide “pegs” (shallow oxide-filled surface regions) are prevalent in HT-UPS when held at elevated temperatures for cyclic testing.

Another factor limiting substantial improvement could be related to the relatively poor oxidation resistance of the HT-UPS when compared to the 316 SS. As mentioned previously, the HT-UPS alloy exhibit a considerable amount of oxidation along the surface cracks. While there is little information available on the oxidation behavior of HT-UPS, the presence of oxide pegs were reported after extended time creep tests [4]. Compared to the CD 316 SS in Figure 7(a), the HT-UPS tested with a  $3.6 \times 10^3$  sec hold time exhibits a thick oxide layer along both the specimen surface and surface-initiated cracks as can be seen in Figures 7(b) and 8. The oxide within a secondary crack is greater than 200  $\mu\text{m}$  in thickness under these conditions. It should be noted that the cycled specimens (316 SS and HT-UPS) were not cooled immediately following testing and spent some period of time at temperature following cycling, so some degree of oxide buildup may be attributable to sustained high-temperature exposure following the completion of the specific test. As was observed in other studies [3], extensive oxide pegging was observed in the  $1.8 \times 10^3$ ,  $3.6 \times 10^3$ , and  $9.0 \times 10^3$  sec for the HT-UPS specimens. Despite the similar test durations, no such oxidation pegs were observed in 316 SS. The negative influence of the air environment and associated oxidation behavior may be responsible for the lack of a creep-fatigue improvement in HT-UPS over 316 SS, despite its demonstrated improved creep resistance and decreased dislocation mobility. As the present intended use of HT-UPS is a structural material for liquid sodium fast reactors, the oxidizing environment seen during mechanical tests is not a practical concern. This work suggests that the degradation during fatigue or creep-fatigue of 316 SS is influenced to a lesser degree than HT-UPS, in which the crack propagation may be accelerated by oxidation processes. In HT-UPS, however, the cyclic and creep damage may play a less significant role in overall failure lifetimes than the damage caused by an oxidizing environment.

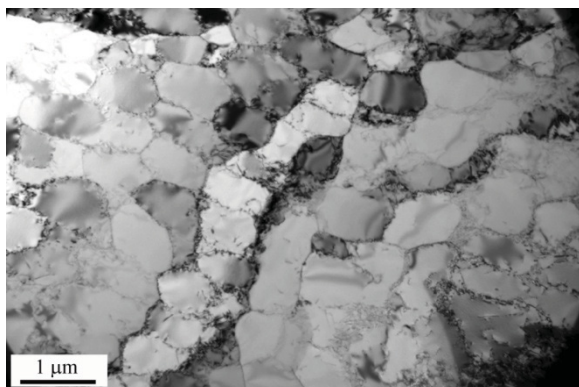
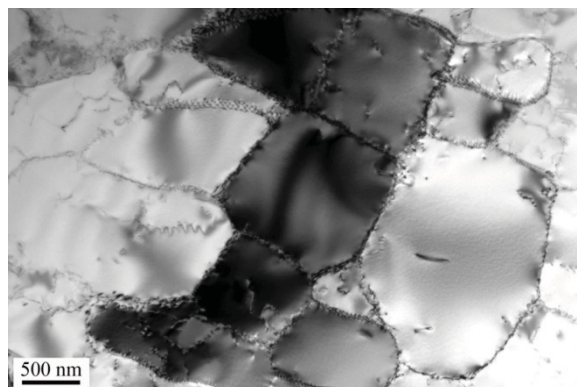
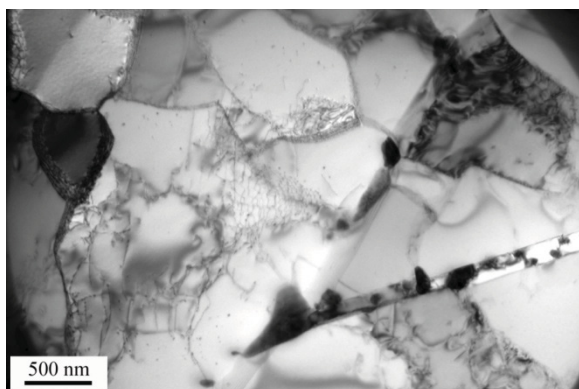
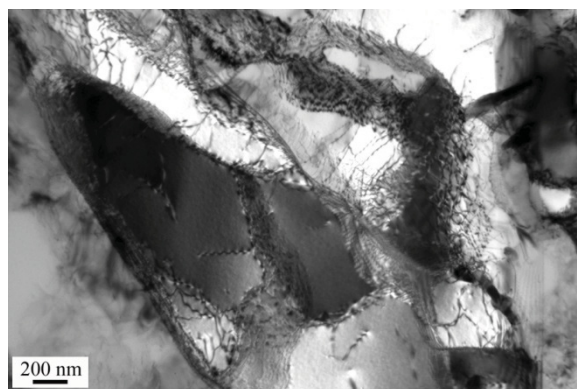
Figure 9. Bright field transmission electron microscope (TEM) images of the equiaxed cellular structure formed during (a, b) fatigue deformation of cold drawn 316 stainless steel and (c, d)  $1.8 \times 10^3$  sec hold creep-fatigue deformation.

The dislocation substructures that form during cyclic deformation of HT-UPS vary dramatically from those observed in 316 SS. Following pure simple fatigue deformation, an equilibrium dislocation cell structure with an approximate cell size of 1  $\mu\text{m}$  is prevalent in the CD 316 SS, as shown in Figures 9(a) and 9(b). The cell interiors have relatively few dislocations. By contrast, there is no clear picture of a cellular structure in the HT-UPS following fatigue deformation, as can be seen in Figures 10(a) and 10(b). In place of the clearly-defined cellular networks, there exist a multitude of dispersed and tangled dislocations interacting readily with the uniform dispersion of 5 nm MC precipitates.

The gage sections of the CD 316 SS and HT-UPS cycled in creep-fatigue for  $1.8 \times 10^3$  and  $3.6 \times 10^3$  were also imaged. Again, 316 SS CD has a clear, equiaxed cellular structure with cell boundaries, examples of which are shown in Figure 9(c) and 9(d). The cell boundaries consist of a well-defined dislocation networks, and, similar to what was seen in fatigue-tested specimens, relatively few mobile dislocations are present in the cell interiors. Conversely, the HT-UPS deformed in creep-fatigue again exhibited no evidence of any sort of cellular structure, and instead revealed a similar tangled dislocation density pinned by the prevalent dispersion of MC precipitates. Figure 10(c) is a bright-field TEM image showing the general distribution of fine MC precipitates (dislocations are purposely absent as a result of TEM imaging conditions). Figures 10(d) and 10(e) reveal the large densities of pinned dislocations observed following creep-fatigue deformation.

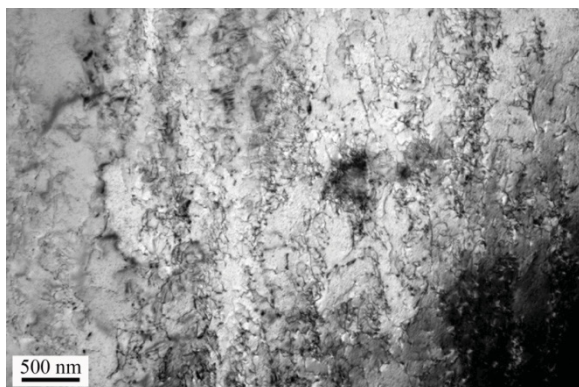
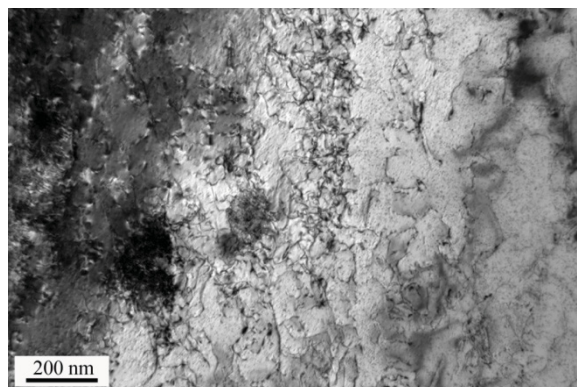
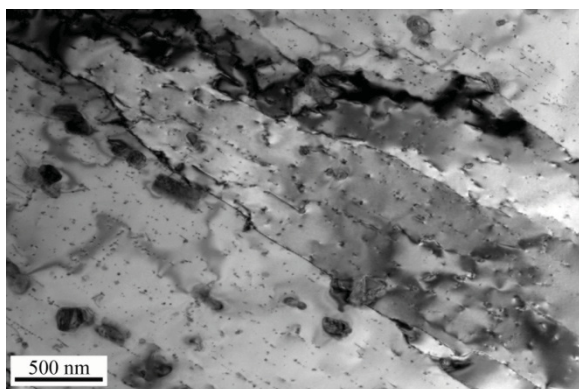
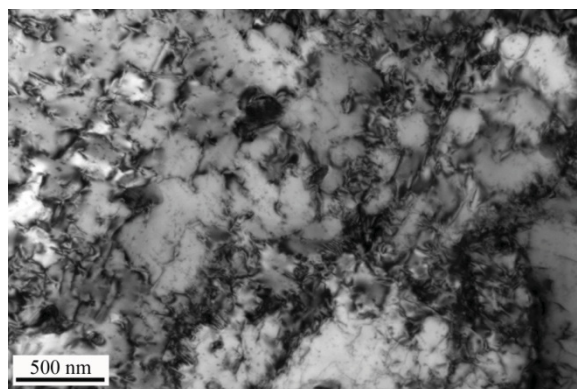
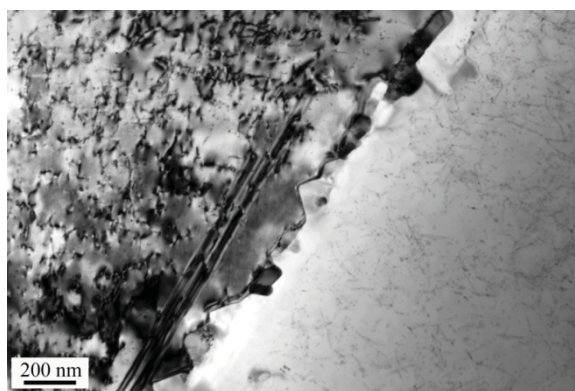
Figure 10. Bright field transmission electron microscope (TEM) images of the dislocation substructure formed during fatigue deformation of HT-UPS (a, b), creep fatigue deformation with a  $3.6 \times 10^3$  sec hold time (c, d), and a  $1.8 \times 10^3$  sec hold time (e).
